Plastic Free Ocean

Civic monitoring of macroplastics and microplastics in small rivers report from Pomeranian and Warmian-Masurian Voivodships in July - September 2019

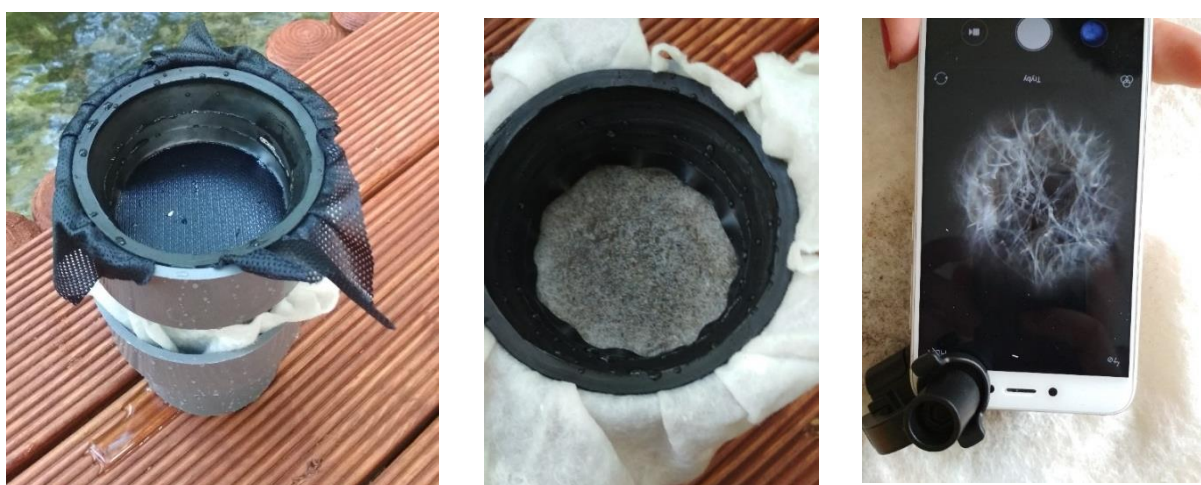
Fig.1. The equipment for microplastics collection and monitoring

The set-up to microplastics collection was consisted of:

- two plastic pipes with the rubber flange,
- 15 pieces of filtration textiles with the pore diameter higher than 0,1 mm,
- 5 pieces of filtration textiles with the pore diameter higher than 1 mm,
- the mobilephone magnifier with 90 x magnification,
- graduated bucket with 10 L volume.

The designed sampling set-up was light and simply to use. It served its purpose well. Both used filter fabrics were a drawback. The first had too large pores, and the second was not uniform enough.

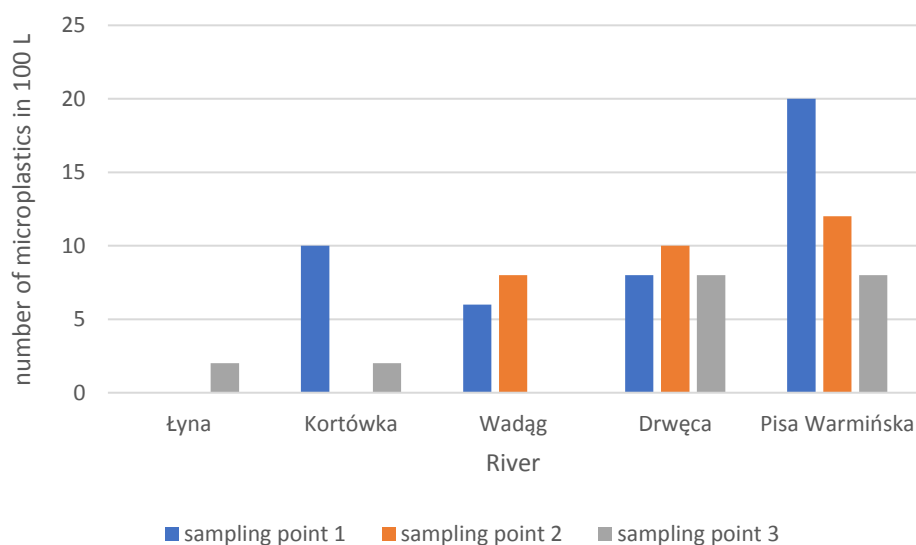
Fig. 3 The number of microplastics in three sampling points in studied small rivers in Warmian-Masurian Voivodeship

The highest number of microplastics (20 items) was found in Pisa Warmińska. It is a place of inhabitants rest. The lowest number of items was collected in Łyna.

Pisa and Wadąg are tributaries of the Łyna. The commune of Barczewo is implementing a project entitled "Development of the banks of the Pisa River" co-financed by the European Regional Development Fund under Measure 6.2 Natural heritage, Sub-measure 6.2.3 Effective use of the resources of the priority axis Culture and heritage of the Regional Operational Program of the Warmian-Masurian Voivodeship for 2014-2020. It is possible that construction works have caused the temporary increase the number of microplastics in waters of Pisa.

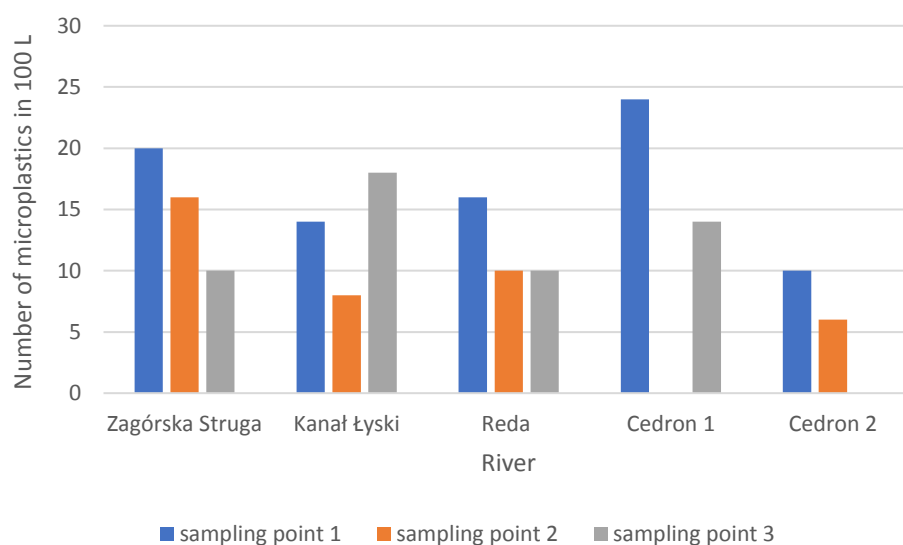
Fig. 4 The number of microplastics in three sampling points in studied small rivers in Pomeranian Voivodeship in region 1.

Zagórska Struga was watched in the vicinity of the town of Kazimierz. There was along a bicycle path, a place of recreation and leisure for both residents and tourists and the area of arable fields. The section of the Łyski Canal near the village of Reda was watched, along a dirt road near arable fields, acting as a watering hole for animals from nearby farms. The section 1 and 3 of the Cedron 1 River and section 2 of Reda River covered the area along provincial roads (number 100, 224 and 218) in the forest area.

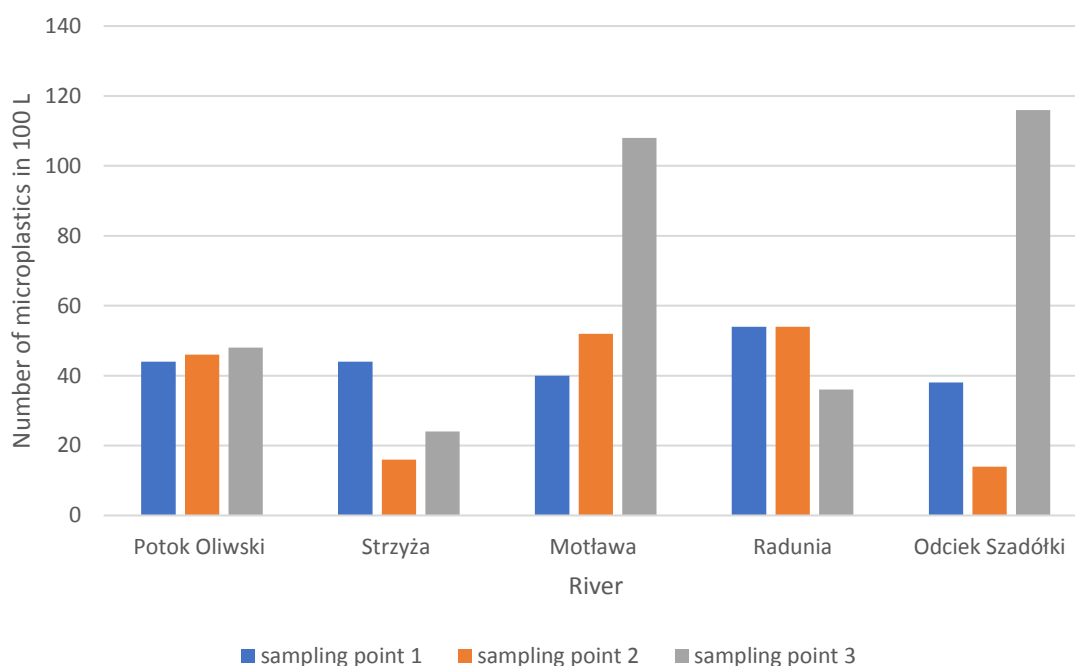
Fig. 5 The number of microplastics in three sampling points in studied small rivers in Pomeranian Voivodeship in region 2.

There were all points located in urban areas, near roads with intensive traffic, in areas where new residential buildings are built or places intensively visited by tourists. Motława is a place intensively used by cruise ships, a water tram and private yachts. There are carried out the construction investments on the river banks.

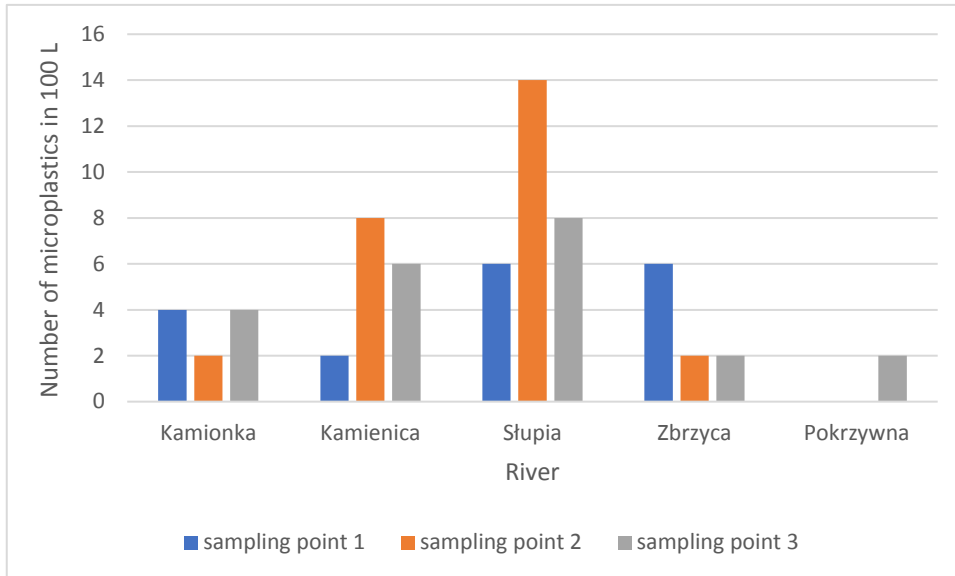
Fig. 6 The number of microplastics in three sampling points in studied small rivers in Pomeranian Voivodeship in region 3.

All sampling points of rivers were in the forest area. The largest river among the monitored rivers was the Słupia River. The largest number of microplastics was also found there. Any microplastics larger than 1 mm were not found. Due to the fact that the majority of sampled places were attractive for tourists, numerous macroplastics contamination was observed.

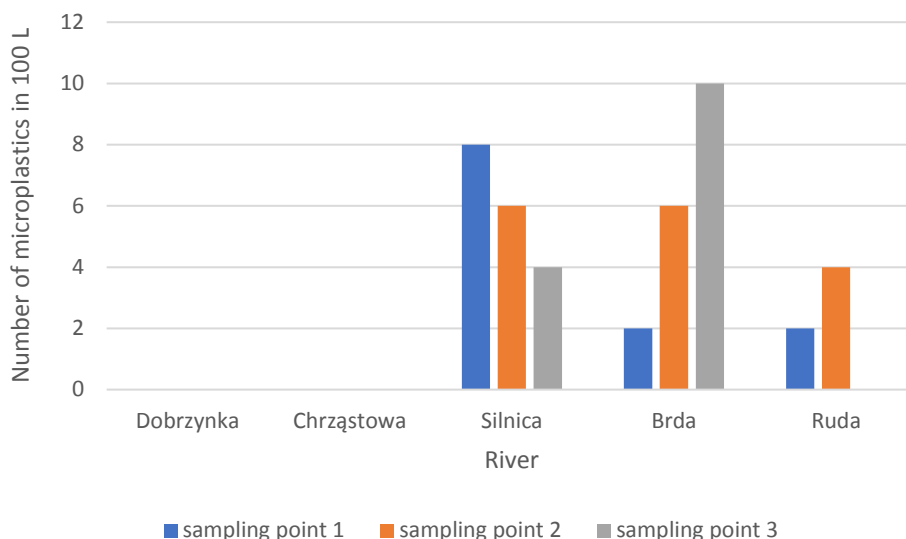
Fig. 7 The number of microplastics in three sampling points in studied small rivers in Pomeranian Voivodeship in region 5.

The sampling points of rivers were located near small towns in the forest areas including canoe routes.

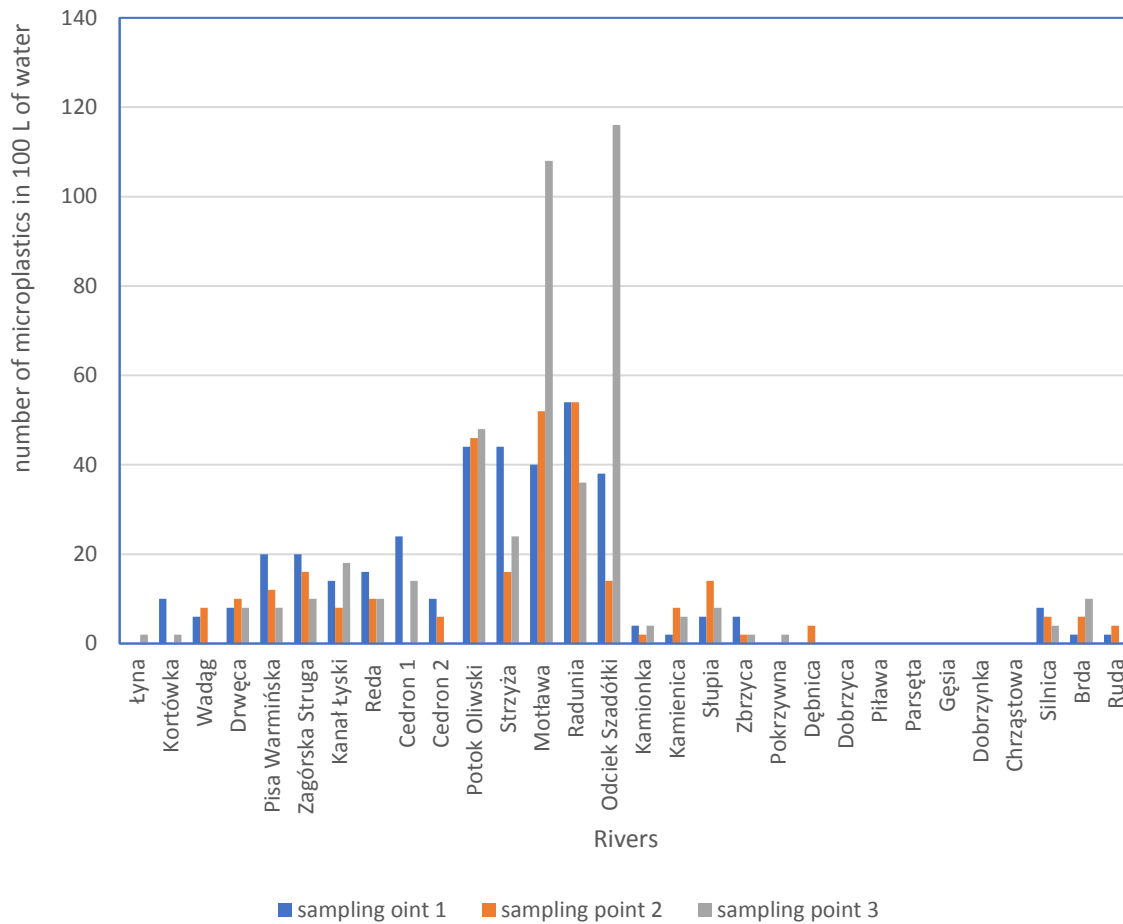
Fig. 8. The number of microplastics in rivers in one region of Warmian-Masurian Voivodeship and five regions of Pomeranian Voivodship

Nowhere microplastics larger than 1 mm were found.

In all studied rivers, except the rivers in region 4, the microplastics with the diameter in range 0.1-1 mm were found (Fig 8).. The highest amount of microplastics were collected form rivers located in urban area, where the construction works have been done. The shipping and sailing were one of the major source of microplastics in Motlawa river (Fig. 8). The rivers located in forest areas were less exposed to microplastics contamination. In urban areas the main microplastics contamination was fibers, while flacks and fibers were recognized in other places (Fig. 9). The microplastics characterized the different colors: blue, black, pink, and red fibers and black, pink, green and transparent flacks.

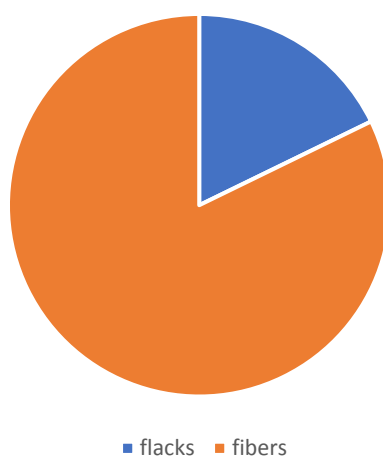
Fig. 9. The flacks and fibers participation in microplastics sampling in all watching regions.

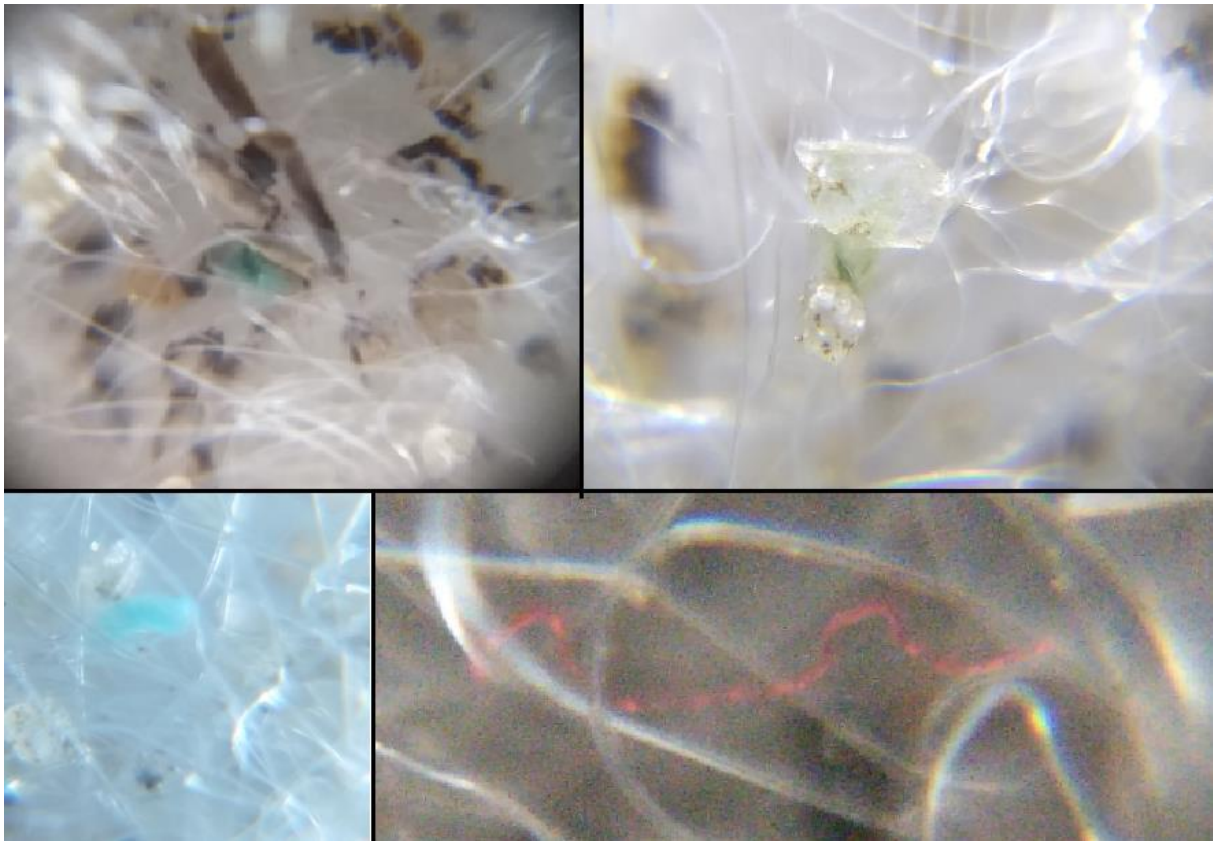
Fig.10. The images of microplastics in flacks and fiber forms collected from rivers.
